# Manhole Inspection Summary

Manhole # S35GG\_018MH

Insp Date: **4/5/07 12:33 PM**

**Location** Address: **101 MT ROYAL AVE**

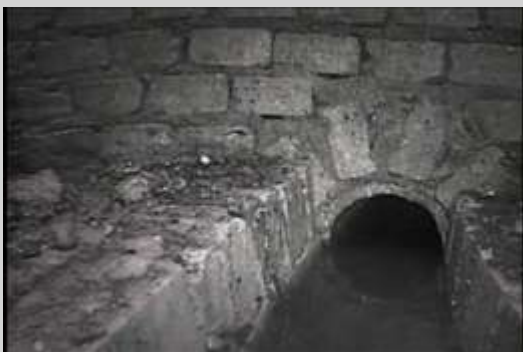
### 8 in. Circular Gravity Sewer

Pipe Material: **Clay** ☐ Pipe Lined

Infiltration: **None** Pipe Seal Cond: **Unknown**
